Rising safety hazard related to hydrogen on-road applications as leave the laboratory environment

Henrik Domanovszky

Graduated engineer of transport Ms.C, LNG.hu Engineering Kft., Hungary

Abstract: Despite the fact that nowadays Hydrogen is mostly considered a carbon-free energy vector, this tiniest molecule is in its artificially separated status and one of the most difficult and dangerous substances to handle on earth. The engineering community acknowledges this fact and treats hydrogen carefully, using it in the chemical industry with a respectable safety record. However, to distribute hydrogen to millions of untrained customers such as vehicle owners seems a parlous idea. Serious risks can arise due to the mass production, the cost sensitivity of which might has a negative impact on material and production quality. Further risks are posed by imprudent user behaviour, unqualified maintenance and repair, in which the unreliable quality of aftersales parts can increase the possibility of faults and equipment time-wear, may lead to additional risks. Any failure within a H_2 -system may incur not only the cost of an unworkable vehicle, but the cost of human lives.

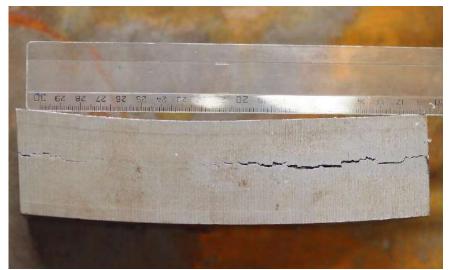
Fig.4.: This excised piece of a hydrogen industrial spherical container shows the hydrogen accumulation deep in the 50 mm wide steel plate, which was even able to straighten the inner side. Under heat and pressure the Hydrogen bubble created bursting force is over 100 MPa range. [Author]

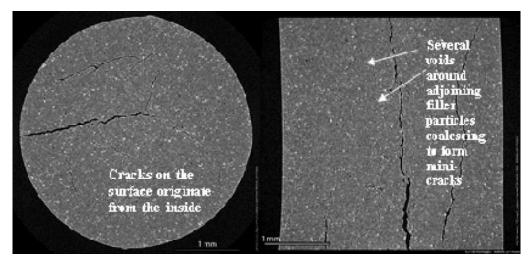
Fig.5.: SNL report [17] gave inside to hydrogen exposure related micro cracks on O-ring

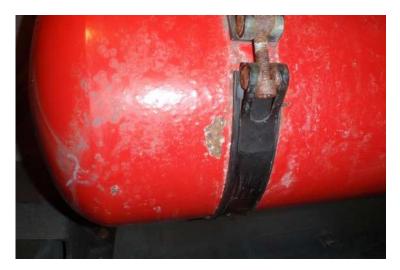
Fig.11.: At the inspection as "not usable" determined Type 1 cylinder under a CNG vehicle, because of the material corrosion. This type of failure can be detected well, if the vehicle inspection is regular and serious. In 2017 there was a wave to recall most of the VW CNG vehicles to check their bottles and had been replaced a large number of them. [Author]

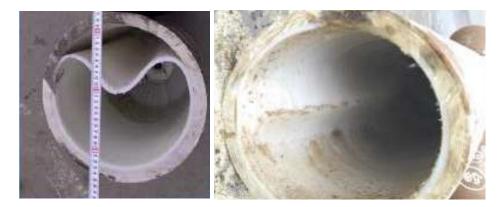
Fig.22.: The blistered liner can see on the left cut up cylinder, at low pressure the strung-out liner come off the epoxy-fibre layer, and the hydrogen accumulating between. On the right the one already cracked liner is visible. The increase of the hydrogen passage through the wrapping resulted. [Source of the photo is uncertain]

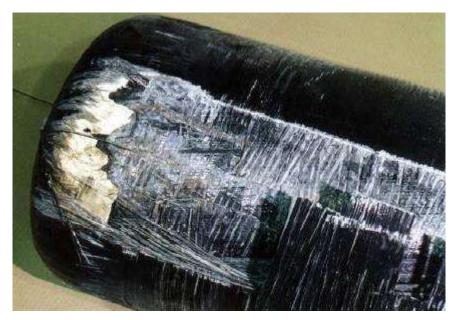
Fig.23.: Bus tank after impacted with an over-bridge [28]

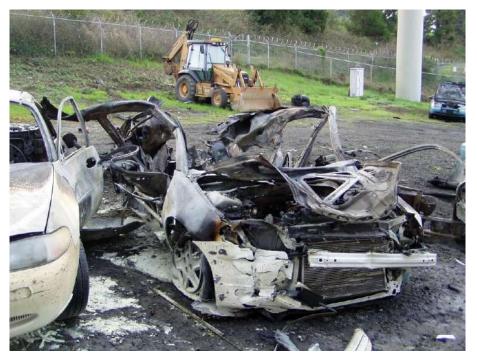
Fig.24.: The case of a CNG propelled Civic in 2007 in Seattle, where the PRD was not opening and actuating releasing the gas. The ruptured tank was landed beside of the excavator [Photo 23, 27]

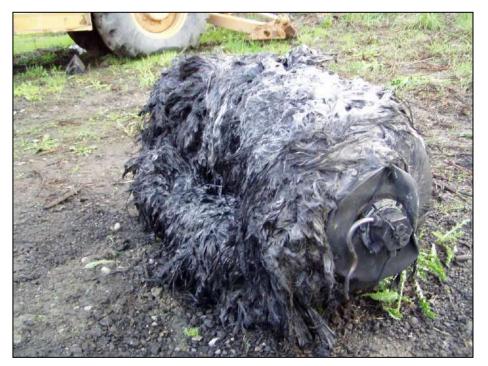
Fig.25.: The bursted and burned cylinder residuum from the Civic [27]

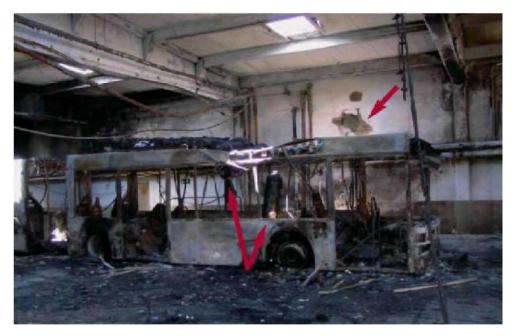
vessels. One of the busses got fire from the engine compartment and in the fire, one after the other tanks released their gas content as it is design to do so. The released gas burnt in the depot and the fire propagated from the back of the bus to another one, which were parked at 1.5 meter behind. "19 of the 20 CNG tanks exposed to the fire did behave as expected." Unfortunately, one TPRD was not releasing and about 15 minutes after the fire started, that tank burst. "A large fragment was propelled in the tank axial direction. It broke through a nearby wall (hole at 3 meters from ground level) flew through the air and damaged another wall located 25 meters further and ended up it's journey on the roof of a bus parked in a nearby depot." [24]

Fig.26.: The above arrow shows where the wall was leaked through by the exploded tank [24]

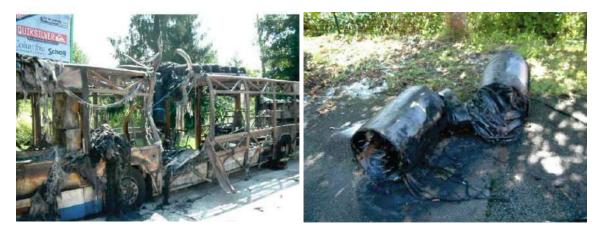
At the Montbéliard accident (2005) the Authors could declare: the TPRD connected to Type 4 tank had not sufficient gas through put, to fulfil the French regulation and the pressure reduction couldn't be fast enough. The fire initially was a battery fire which propagated throughout the complete bus. Just 3 months later in the same year, a same type of bus in Bordeaux have been burned out, because of vandals threw a Molotov cocktail inside the bus and the first cylinder exploded again.

Fig.27.: The burned out bus in Montbéliard, and the residue of the cylinder, which splitted in two parts. The initial problem came from the electrical circle of the bus [24]

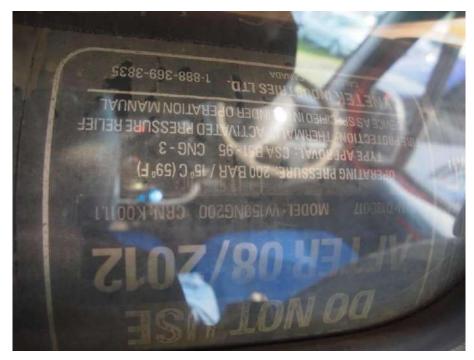
A self-confident Hungarian vehicle owner in 2015 additionally built into his, from factory CNG powered LCV three piece of type 3 tanks. His action is even stranger to understand, since the clear sign on the tank: DO NOT USE AFTER 08/2012. This intention could not be bigger and better displayed.

Fig.29.: The additionally built-in tanks in the luggage compartment appear through the window on the LCV cabin back wall. The driver had this view as turned behind. Could not face to even bigger notice that the tanks are expired more than 3 years earlier [Author]

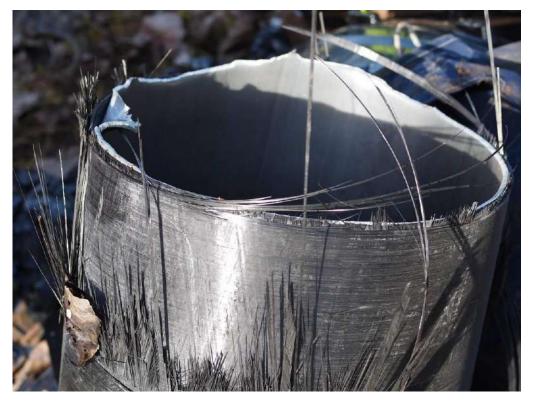
As finished the "tuning", opened the valves and found that everything works properly. Drove to the CNG station and without any notice about the modification to the employee, let the vehicle fill. However, the station employee at a certain point recognized that the normally filling quantity exceeded and let the filling continue. Somewhere around 100 bar one tank was ruptured into two parts. The blast wave was speed up the part of the tank to tore off the vehicle's sliding door, flying into a parking urban bus's window, about 6 meters away. Attacked the handrail, from where changed the direction and flew out through the front window. Another part of the tank simply trampled to the ground a fuel dispenser. The employee seriously injured. The gas was not ignited, and no flame occurred, because of natural gas. In the presence of Hydrogen that for sure would happen.

Fig.30.: The carbon fibre wrapping was capitulating way under the design pressure. In the middle, the metal liner material flown. [Author]

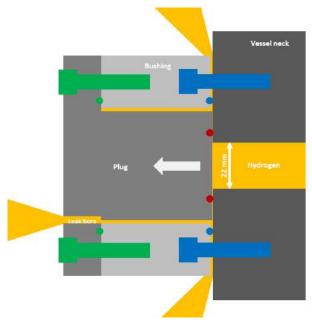
Red sealing fails

Fig.35.: The drawing for the explanation, how the not properly torqued blue bolts were resulting the start of the small leak and the sequenced progress of the accident [34]

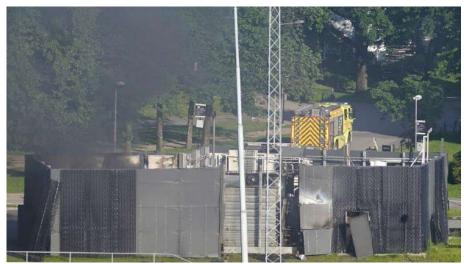
Fig.37.: The pressure wave lifted up the roof of the compartment and through away in several hundred meters [photo: Heiko Junge / NTB scanpix]
